CORNER RECORDAPN No. 84C-865-1-3 (Optional)Document Number CR 6203Unincorporated Eden TownshipCounty of Alameda, CaliforniaBrief Legal Description In Seaview Ave., Tr 5373, Bk.171, Pg.44

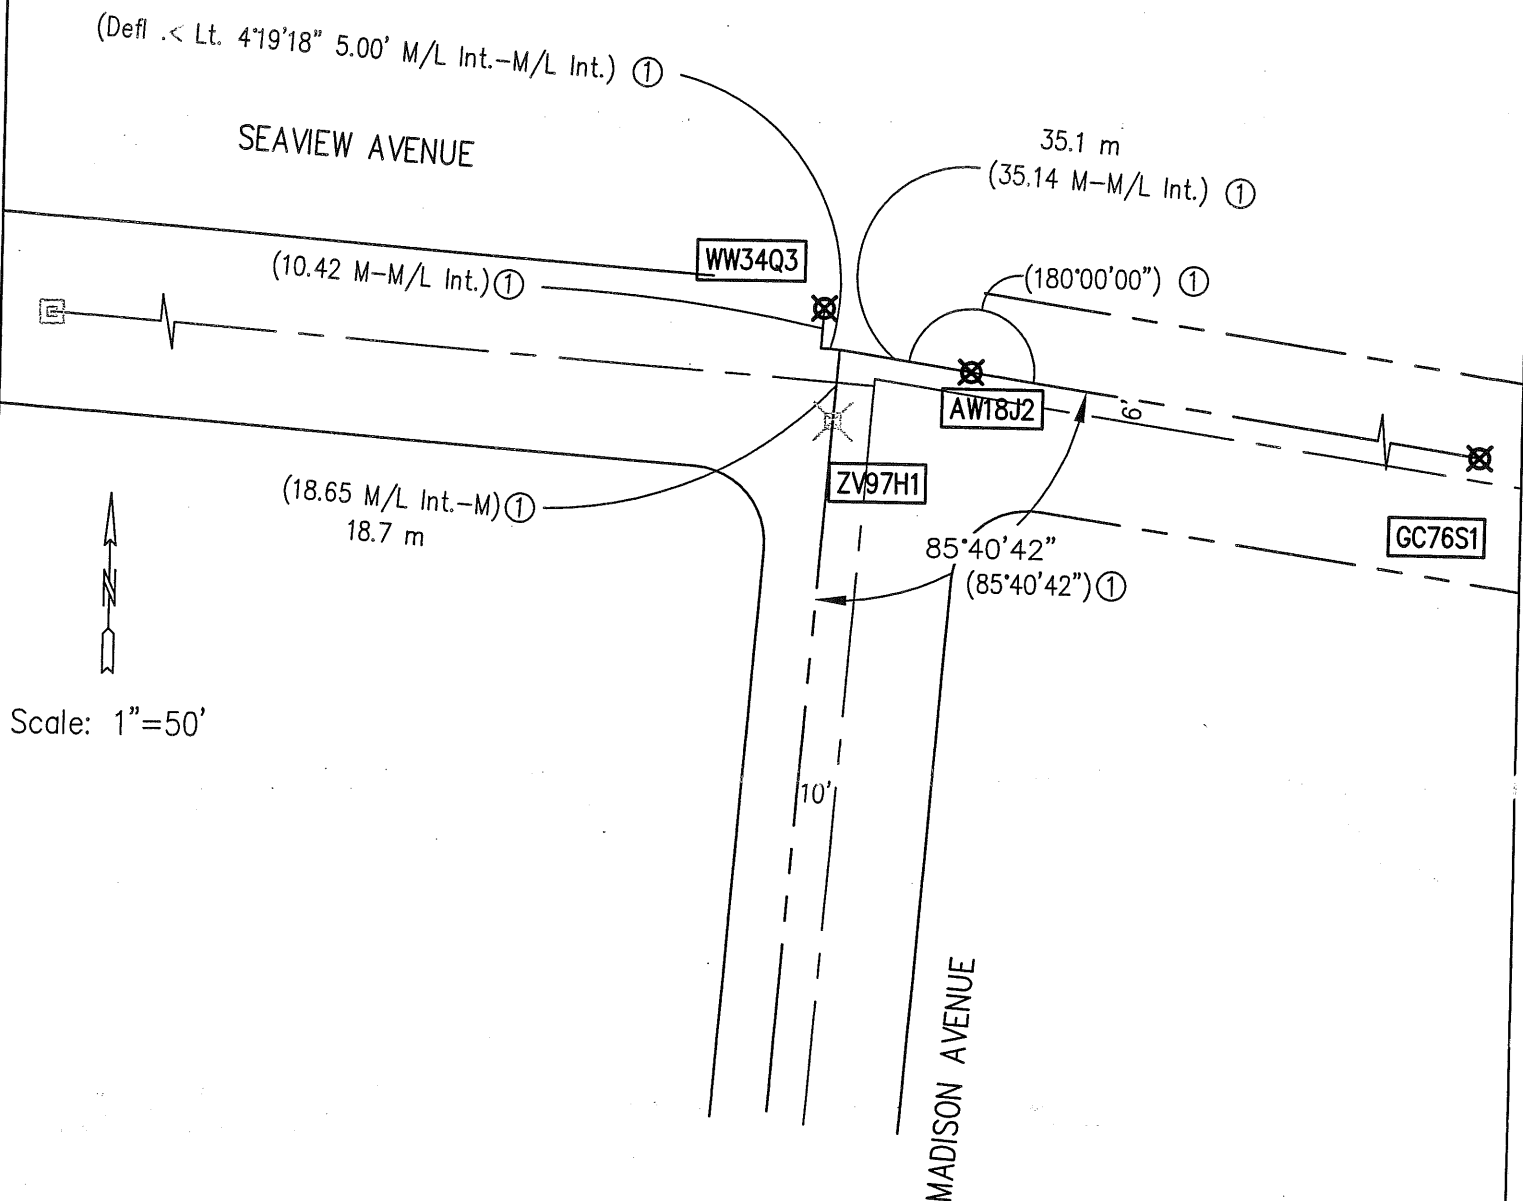
Identification and type of corner found: Evidence used to identify or procedure used to establish or reestablish the corner: Using record map relationships from nearby found monuments, a field survey with RTK-GPS methods was conducted establishing a calculated record location for the subject monument. At this calculated record location the pavement surface was thoroughly searched with a magnetic locator, but since no signal was returned detecting the monument's existence it was concluded to have been destroyed prior to the date of this survey.

Monument locations are approximate as only lids or magnetic locator signal positions were located. See Page 2.
